Insurance Survey Report

“Vessel Name”

Blondecell Marine Tradewind '35

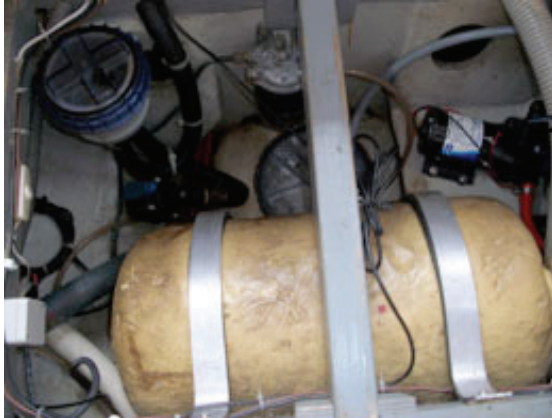
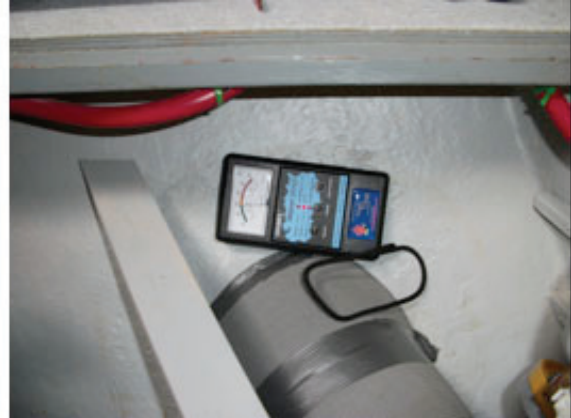
Moisture readings	Our moisture readings for the hull indicate that the hull is in good condition. See Detail below.
Condition of bilges	The bilges are in good condition. They are clean and dry.
Skin Fittings	These were visually examined and appear to be in good condition.
<p>Findings</p> <p>Moisture Readings for the internal hull were taken from the mid-ship section and the starboard side aft cabin. They indicate that the hull is in good condition. The structure appeared to have been solidly built to a good standard. The hull was especially examined at the points where the bulkheads were fitted and no sign of a hard spot in these areas were noted nor were there any signs of gel coat cracking indicating that the shell was "hinging".</p> <p>Most of the bonding was hidden by lining and cabinetry and could not be inspected.</p> <p>Where visible, the bondings, bulkheads and stringers appeared to be secure and free of defects and the laminates appeared to be in good order.</p> <p>The skin fittings / valves were checked and appear to be in good condition.</p>

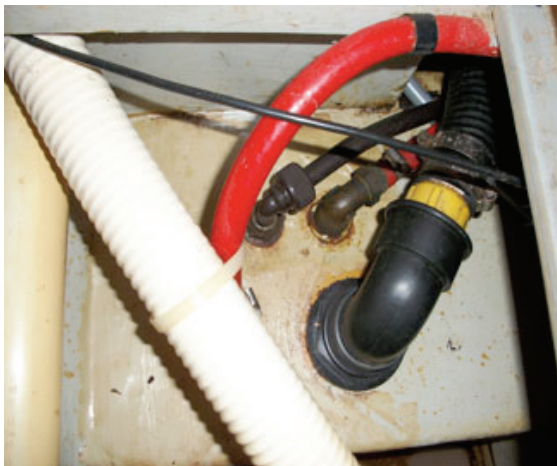
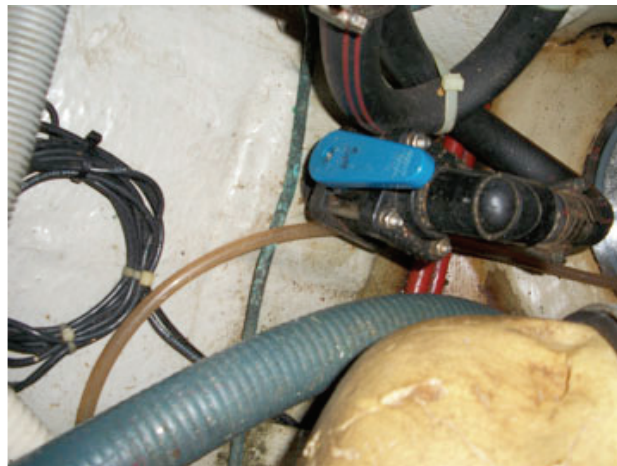
Location	Use	Valve type & material	Clips	Condition
Midships Bilge	Toilet system outlets	Through Hull Fitting & Valves	Jubilee	They are in condition.
Bathrooms & Kitchen area.	Wash basin	Through Hull Fittings & Valves		They are in good condition.
Bow area	Speed Gage	Through Hull Fitting		Good condition.
Engine Bay Bilge	Seacock Isolation Valves			Engine seacock isolation valve was in good order.

The Skin valves and Seacocks appear to be in good general condition on visual inspection.

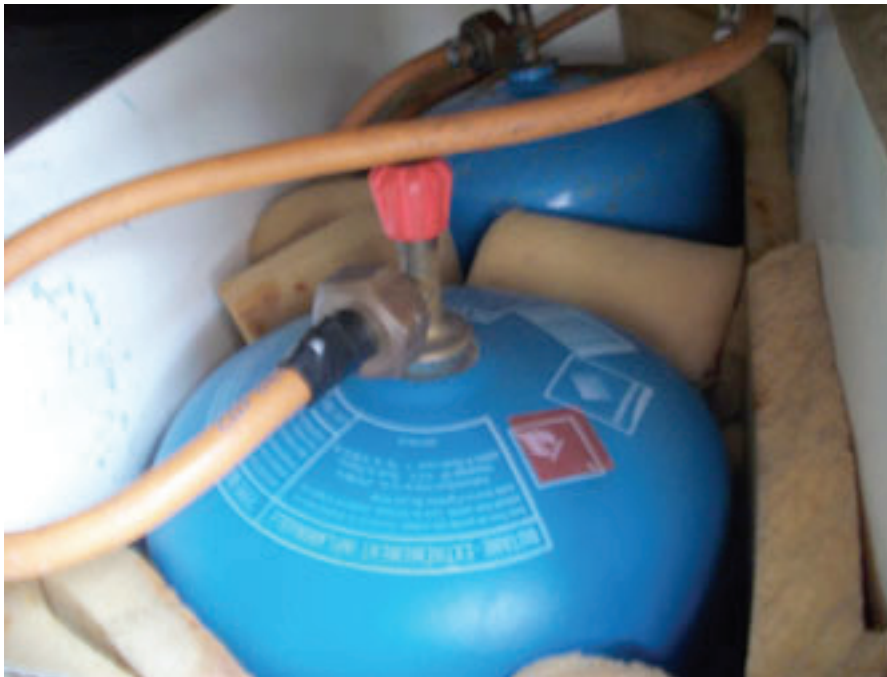
Type / Location of Cylinders	Small gas cylinders x 2.
Vented Locker	The locker was adequately vented through the bottom of the locker.
Regulator	A regulator valve was located on the lead gas cylinder but not on the spare.
Piping	High Pressure LPG Date of gas pipe unknown.
Appliances	The gas supply is to operate a cooker in the saloon area.
Ventilation	Ventilation is good.
Comments	
Gas pipe was being replaced at time of survey. Original pipe age was unknown.

The gas pipe for the internal stove was past its expiry date but this was being replaced as the survey was being carried out so this should not be a problem.

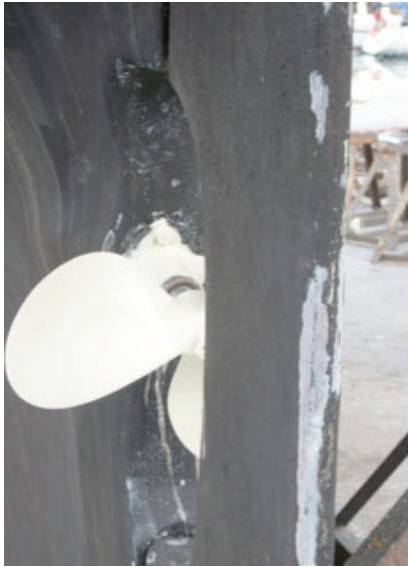
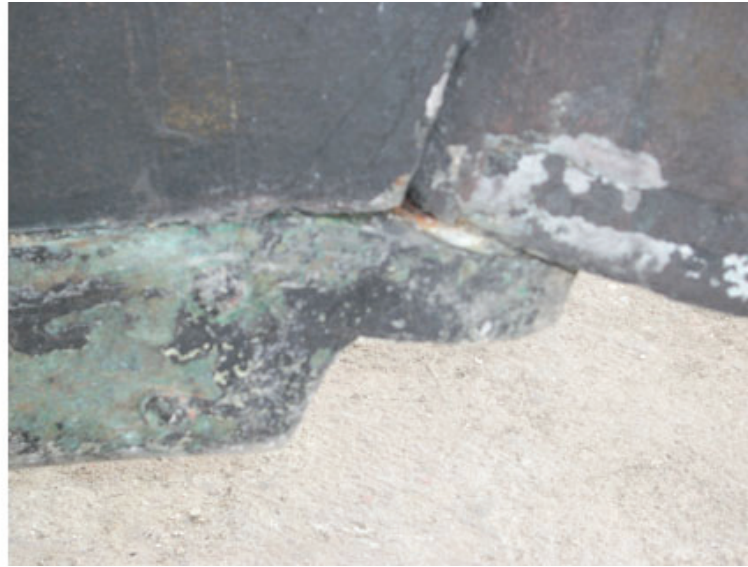
Rudder	1 x Spade Rudder was visually inspected and looked to be in good condition. It operated correctly but the internal workings could not be inspected thoroughly as the steering linkage mechanism runs behind the main engine. The steering was operated without the engine running and appears to be in good order.
Rudder Carrier	This was attached to the external transom and appeared to be in good condition. Internal fixings could not be inspected.
Propeller x 1	Three Bladed Conventional Propellers. It is in good condition.
Shaft	Feels smooth when rotated by hand. Shaft bush looks to be in good order.
Stern gland	Water Lubricated stern gland is in good condition. It was not checked when the vessel was on the water but no signs of water ingress was found.
Anodes	Hull Anodes are new and in good condition.

The steering operated correctly but the internal workings could not be inspected thoroughly as the steering linkage mechanism runs behind the main engine.

The Stern gland visually appears in good condition. It was not possible to check the full operation of the Stern gland as the vessel did not undergo a Sea Trial.

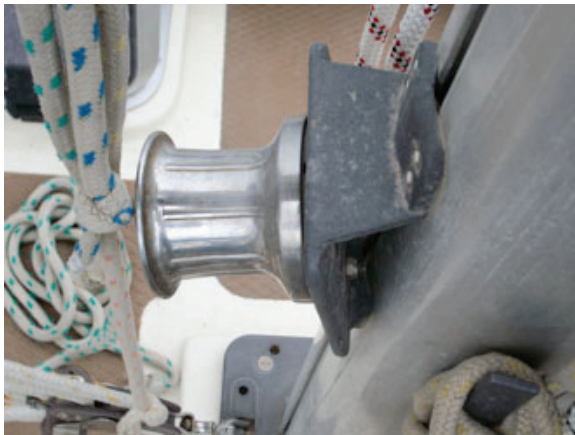
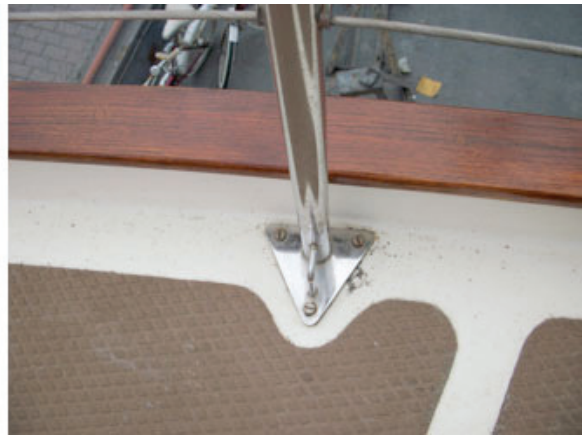
Cleats / bollards	Cleats could only be checked from the hull side they appeared to be in good order.
Bow roller	In good order.
Stanchions	In good order but the internal fixing points could not be checked.
Pulpit	This appears to be in good order. When weight was applied it felt slightly loose. The internal fixing points could not be checked due to structural panelling.
Anchor (No. / Type)	There is a 135 lb anchor. It is in good condition.
Anchor Cable	The anchor chain is 10mm thick and appears in good condition.
Anchor Winch	The Anchor winch appears in good working order and the anchor operates correctly from the controls.
Bathing platform	This appeared to be in good structural order but the internal fittings could not be accessed and have not been visually inspected. The platform is made from stainless steel.

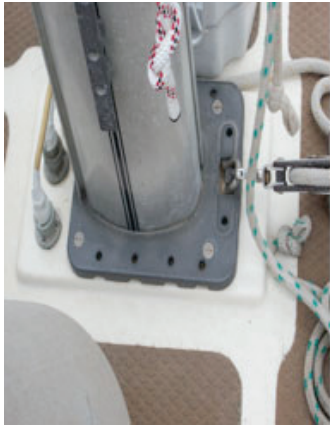
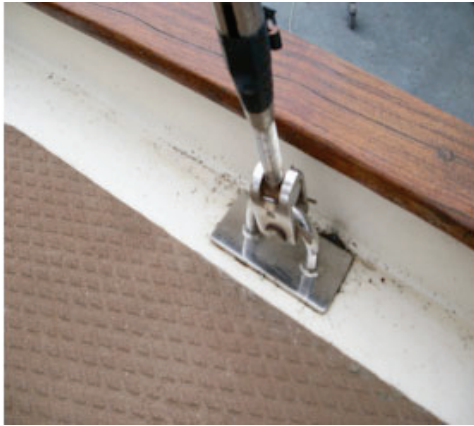
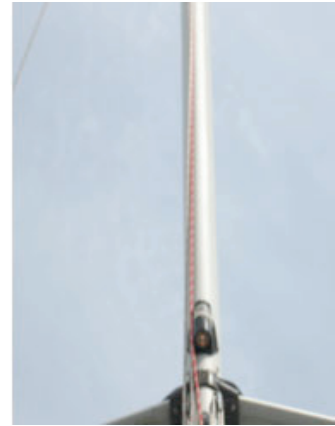
Mast step	The mast step was visually inspected and appeared to be in good condition. It was inspected from the deck side only and not internally from the saloon area as the ceiling panelling restricted an internal inspection.
Mast; material / Method of construction	This was made up of Aluminium and the method of construction was folded Aluminium.
Spreaders / Jumpers	These were inspected from the deck side only. They were inspected with binoculars and appeared in adequate condition.
Boom	The boom appeared in adequate order with no visual signs of any prior damage.
Standard rigging: Shrouds	These were inspected from the deck side only. They were inspected with binoculars and appeared in good condition.
Standard rigging: Backstay	These were inspected from the deck side only. They were inspected with binoculars and appeared in adequate condition.
Standard rigging: Forestay	These were inspected from the deck side only. They were inspected with binoculars and appeared in good condition.

Forestay step	The Forestay step was inspected from the deck side only and not internally as panelling restricted an internal inspection. From the visual inspection it appeared to be in adequate working order.

Age of Rig: Mast, Boom, Rigging or Date last tested	<p>The mast, boom & rigging appear to be original which would make them 19 years old. Date of last test unknown. Rigging should be checked and where necessary replaced every 10 years.</p> <p>The rigging should be checked thoroughly by a qualified rigger and the mast should be dismantled and placed in a cradle for a detailed inspection.</p>
Running Rigging	This was inspected and seemed to be in good working order.
Hilliard Winches	The Hilliard winches were working correctly but were not tested under load and were visually inspected from the deck side only. The internal fixings could not be checked due to panelling.

The Mast, Rig and Fittings to the deck appeared to be in functioning order from what could be visually inspected from the deck level only but the last date of renewal of the rigging is unclear.

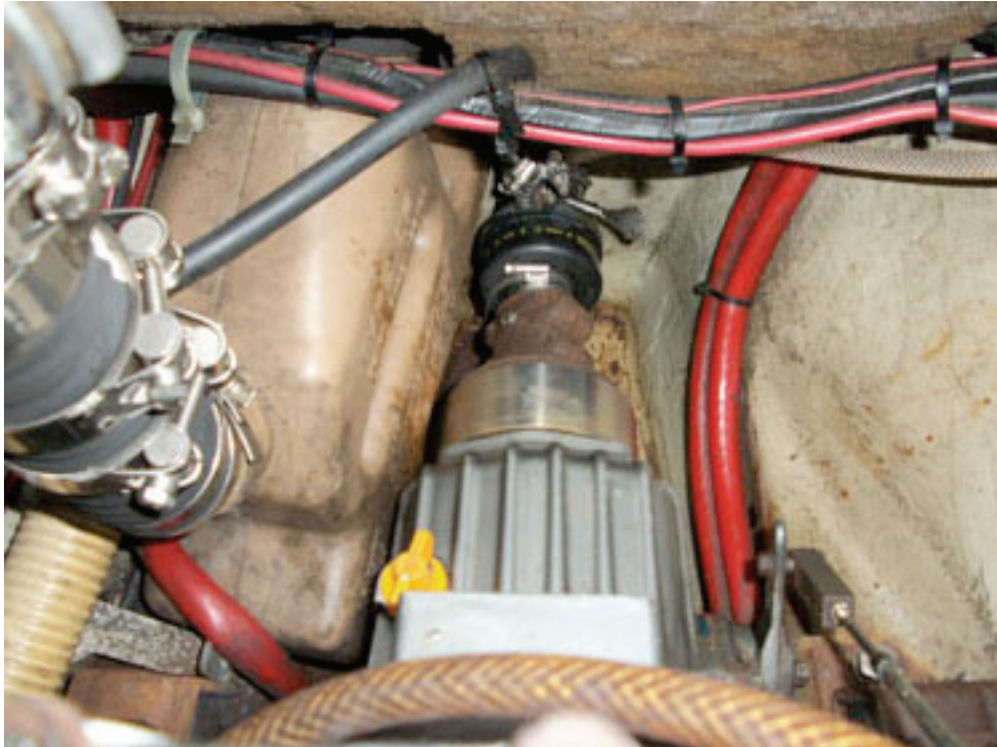
Main engine type	YANMAR 3GM 30F (27HP) DIESEL.
General condition	From a visual inspection the engine appears to be in good condition.
Engine bearers	These can only be accurately checked when the engine is running. We would recommend a Sea Trial to test these.
Engine mountings	Visually these appear to be in working order but we would recommend a Sea Trial to test these properly. Some corrosion was found.
Gearbox	Visually the gearbox appears in working order but we would recommend a Sea Trial to test it properly.
Shaft coupling	Visually the shaft coupling appears in working order but we would recommend a Sea Trial to test it properly.

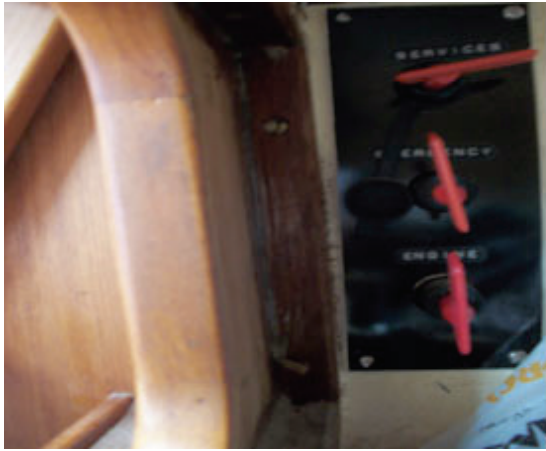
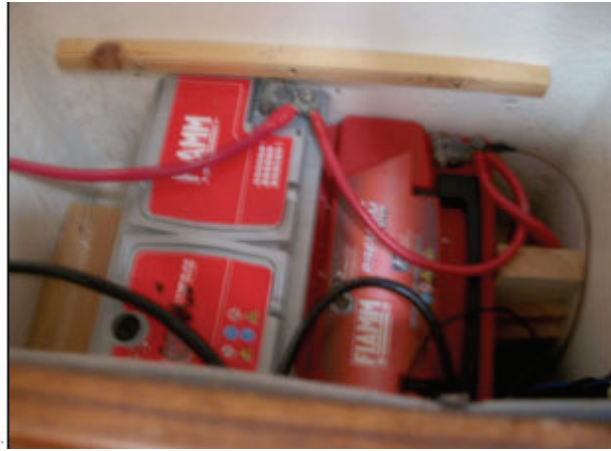
<p>Battery stowage / Ventilation</p>	<p>Battery stowage is in good condition. They are sufficiently secured.</p> <p>There are two main battery supplies with average ventilation currently but this was being modified at the time of survey to increase ventilation.</p>
<p>Battery condition</p>	<p>The battery condition is to a high standard. They are new batteries in good order and contain correct levels of internal battery fluid.</p>
<p>Isolation switches</p>	<p>There are three isolation switches for the batteries; Services, Emergency, and Engine.</p> <p>They are in good working order.</p>

Battery ventilation was adequate but modifications to improve the ventilation system were being carried out on the date of survey.

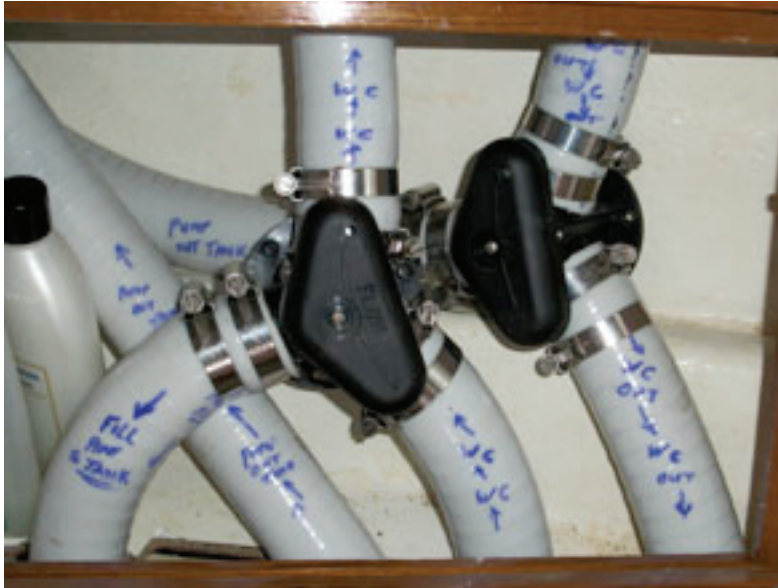
Pipe work	The pipe work is plastic and what was accessible was inspected and found to be in good order.
Skin fittings	The connections to the toilet system appeared to be in good order.
General condition	This visually appears in good working order.

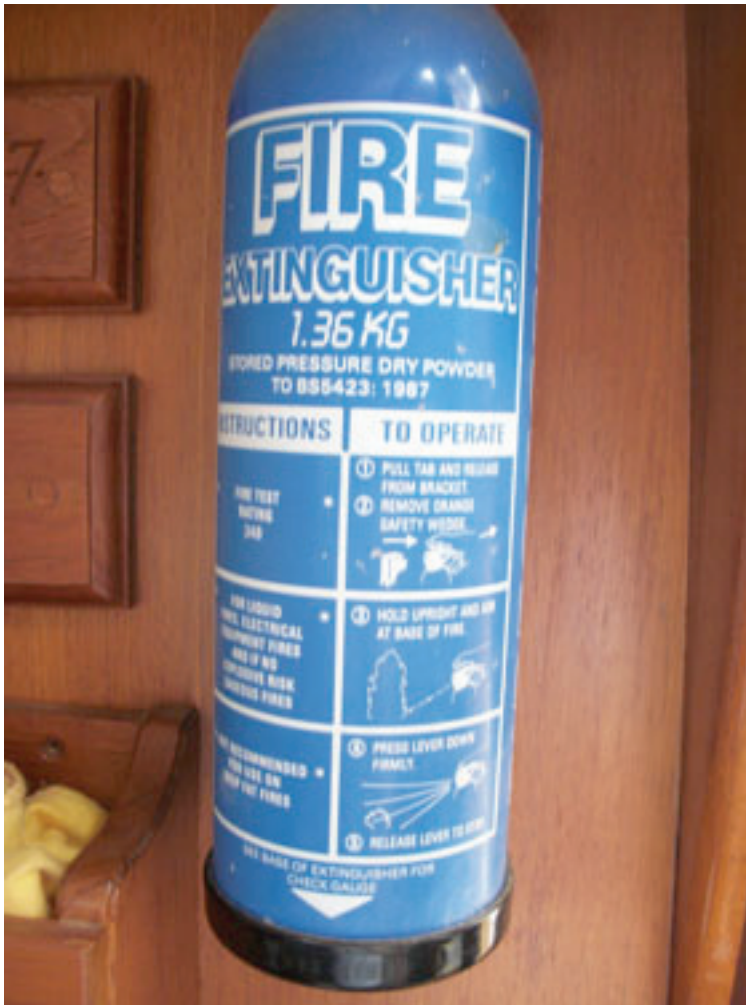
Item	Condition & location
Fire extinguishers	Extinguishers x 3 located in cockpit area with no date. We recommend these be replaced so they conform to safety standards.

There are three fire extinguishers on board that are not dated. We would recommend that these be replaced in order to comply with safety requirements.
